OCH PROPERTY

OCH CASE STUDY

SOLAR WALL RETROFIT

"Solar Wall Uses Renewable Energy to Heat Building, Saving Natural Gas"

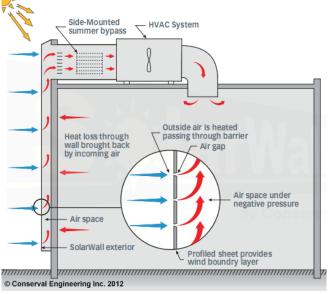
HOW THE SOLAR WALL WORKS

The solar wall at Clementine Towers consists of a dark, perforated panel assembly with a six-inch plenum space over insulation directly installed on the structural wall. The cladding was installed in a similar manner to conventional panelized cladding assemblies.

The sun's radiant energy is absorbed and warms the building's' southfacing, dark colored panels. Exterior air is drawn in through perforations in the cladding panels and, as it is warmed by the heated cladding, the air rises through the plenum space (cavity) behind the panels. The warm air rises to the top of the plenum space and is then directed to the rooftop make-up air unit (MAU). Typically, the MAU burns natural gas to heat cold outdoor air before delivering it into the building. Having the air pre-heated by the passive solar plenum reduces the amount of heating required using natural gas, thereby saving energy and costs.

The solar wall passive heating system provides the greatest potential for energy savings during and fall the spring seasons, when outdoor temperatures are neither too cold nor too hot. There are also significant energy saving benefits during the winter when the exterior air is cold and the cladding is exposed to the sun. When the

exterior ambient temperature rises above 15 °C, mechanical dampers in the solar wall supply ductwork are closed, preventing overheating of the building.
