# OCH CASE STUDY

## WINDOW & BALCONY DOOR REPLACEMENTS

“Saving Energy, and Extending Building Life Address”

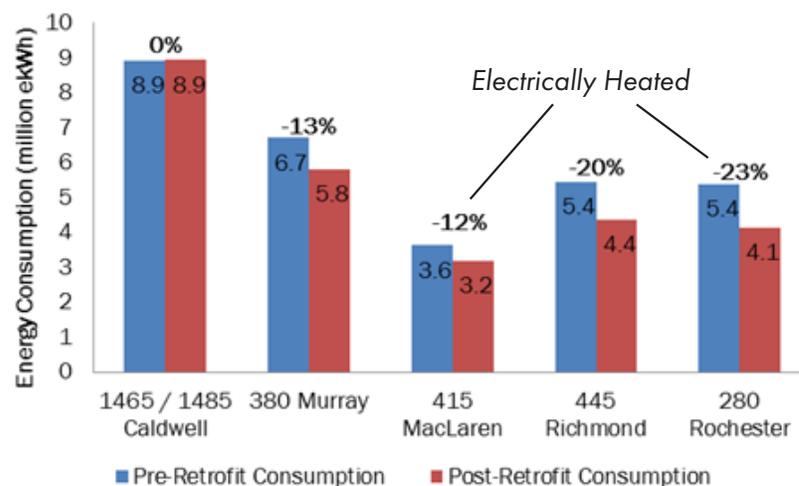
Figure 1: Pre- versus Post-Retrofit Energy Consumption

In the 12 months prior to the retrofits, the total energy consumption of the buildings was approximately 30 million equivalent kilowatt-hours (ekWh)<sup>1</sup>. In the 12 month period after the retrofits were completed, energy consumption decreased to 26 million ekWh (Figure 1)<sup>2</sup>, saving \$145,000 in costs<sup>3</sup>. Replacing the windows and balcony doors resulted in average energy savings of 14%. Each property reduced its energy intensity by between 0 to 6.5 ekWh per square foot per year (Table 2 next page).

- 1 Pre-retrofit consumption is based on the following periods, and is normalized for weather:  
280 Rochester – July 1, 2009 to June 30, 2010  
380 Murray – June 1, 2009 to May 31, 2010  
415 MaClaren – March 1, 2009 to Feb 28, 2010  
445 Richmond – September 1, 2009 to August 30, 2010  
1465/1485 Caldwell – September 1, 2009 to August 30, 2010
- 2 Based on October 1, 2013 to September 30, 2014 data for all sites except 280 Rochester. Post-retrofit energy consumption for 280 Rochester was based on October 1, 2012 to September 30, 2013 data because 2014 natural gas data is not available for this site. Data is normalized for weather.
- 3 Cost savings are based on an average 2014 natural gas rate of \$0.36/m<sup>3</sup> and an electricity rate of \$0.11/kWh.

MaClaren Towers (415 MaClaren), which is electrically heated, achieved the greatest electricity savings post-retrofit (290,000 kWh). The other

electrically-heated building retrofitted at 280 Rochester saw a slight increase in electricity consumption (of 33,000 kWh), but achieved the greatest natural gas savings (120,000 m<sup>3</sup>) and had the highest reduction in overall energy consumption amongst the five buildings (1,300,000 ekWh).

The remaining two buildings, 380 Murray and 445 Richmond, are both heated by hydronic gas-heated radiators, and achieved significant natural gas savings following the retrofits.
